# City of Lexington, Nebraska.

Redevelopment Area #6.

Blight & Substandard Determination Study

General Redevelopment Plan.

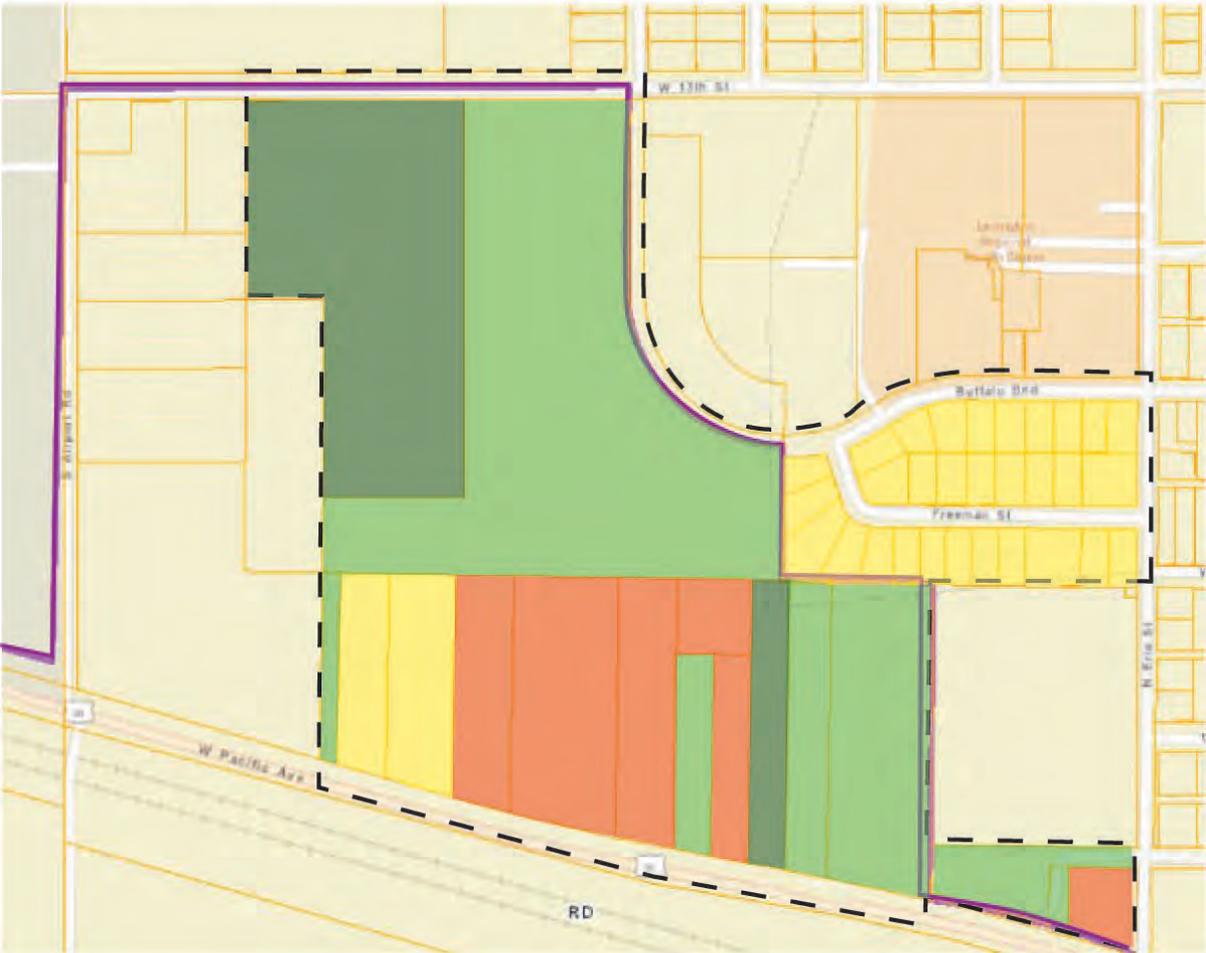
**ILLUSTRATION 2:**

CITY OF LEXINGTON, NEBRASKA  
 REDEVELOPMENT AREA #6  
 EXISTING LAND USE MAP

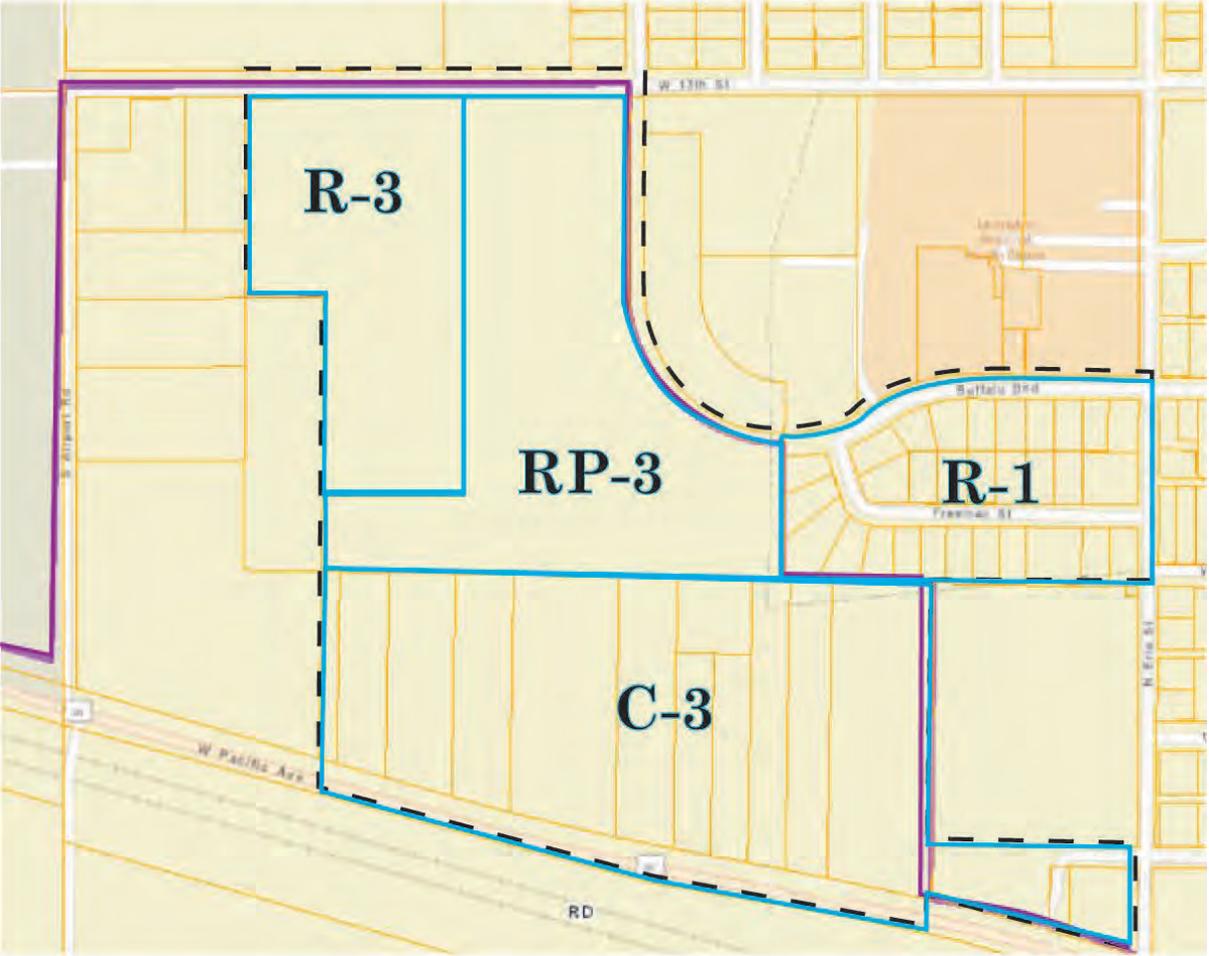
**ILLUSTRATION 3:**

**Illustration 3, Page 14** identifies the existing **Zoning Districts** in **Redevelopment Area #6**. Four individual Zoning Districts are present within the **Area**, including “Single-Family Residential District (R-1),” “High Density Residential District (R-3),” “Planned Residential District (RP-3),” and “Highway Commercial District (C-3).” Zoning activities throughout the **Redevelopment Area** are administered by the City of Lexington.

CITY OF LEXINGTON, NEBRASKA  
 REDEVELOPMENT AREA #6  
 EXISTING ZONING DISTRICTS MAP

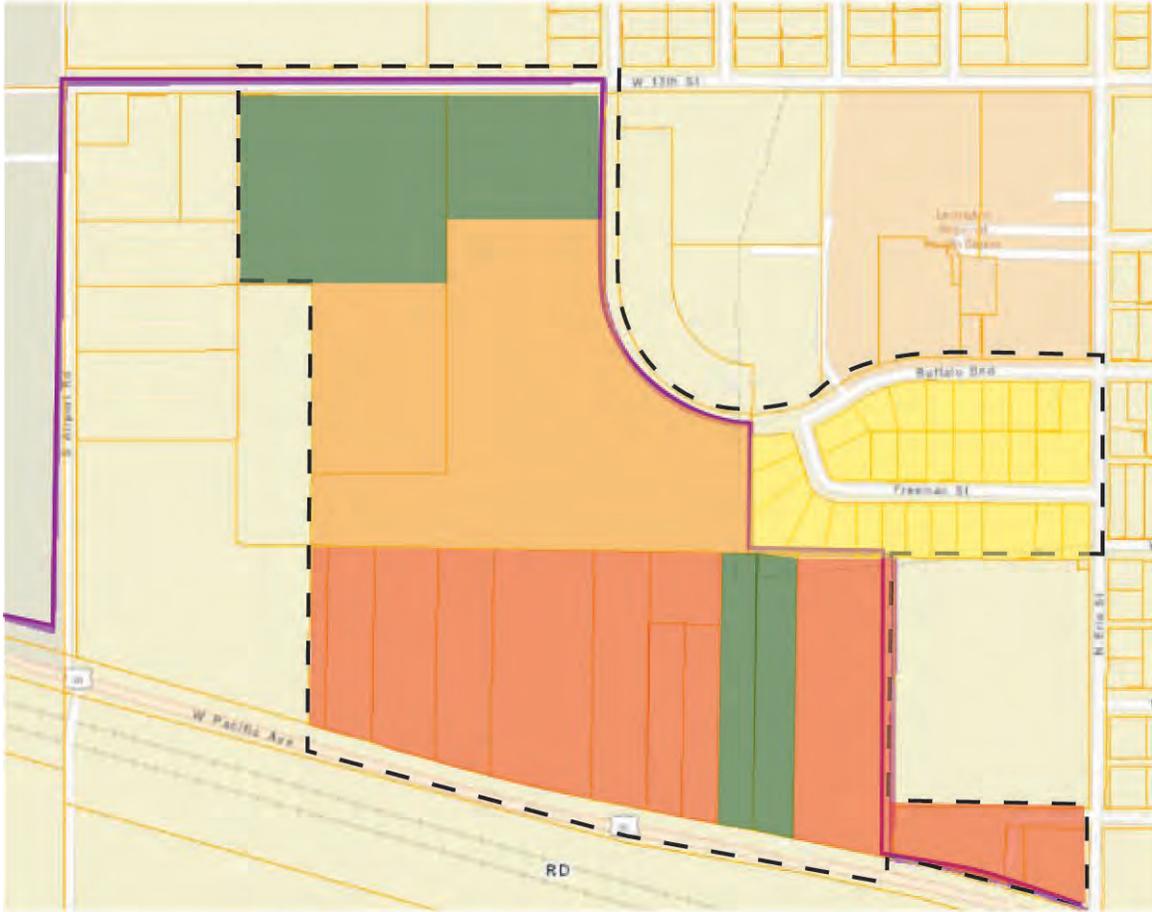
**ILLUSTRATION 5:**

**Illustration 5, Page 49**, features a **Future Land Use Map**, which identifies the land use density and coverage, as well as a general site plan for the **Redevelopment Area**. The recommendations in this **General Redevelopment Plan** are consistent with the *Lexington Comprehensive Plan* and *Lexington Zoning/Subdivision Regulations*.

The future land use patterns within the **Redevelopment Area** support commercial development on both vacant lands and existing properties adjacent Highway 30, as well as multi-family residential and public land use development on vacant lands adjacent W 13<sup>th</sup> Street.

CITY OF LEXINGTON, NEBRASKA  
 REDEVELOPMENT AREA #6  
 FUTURE LAND USE MAP

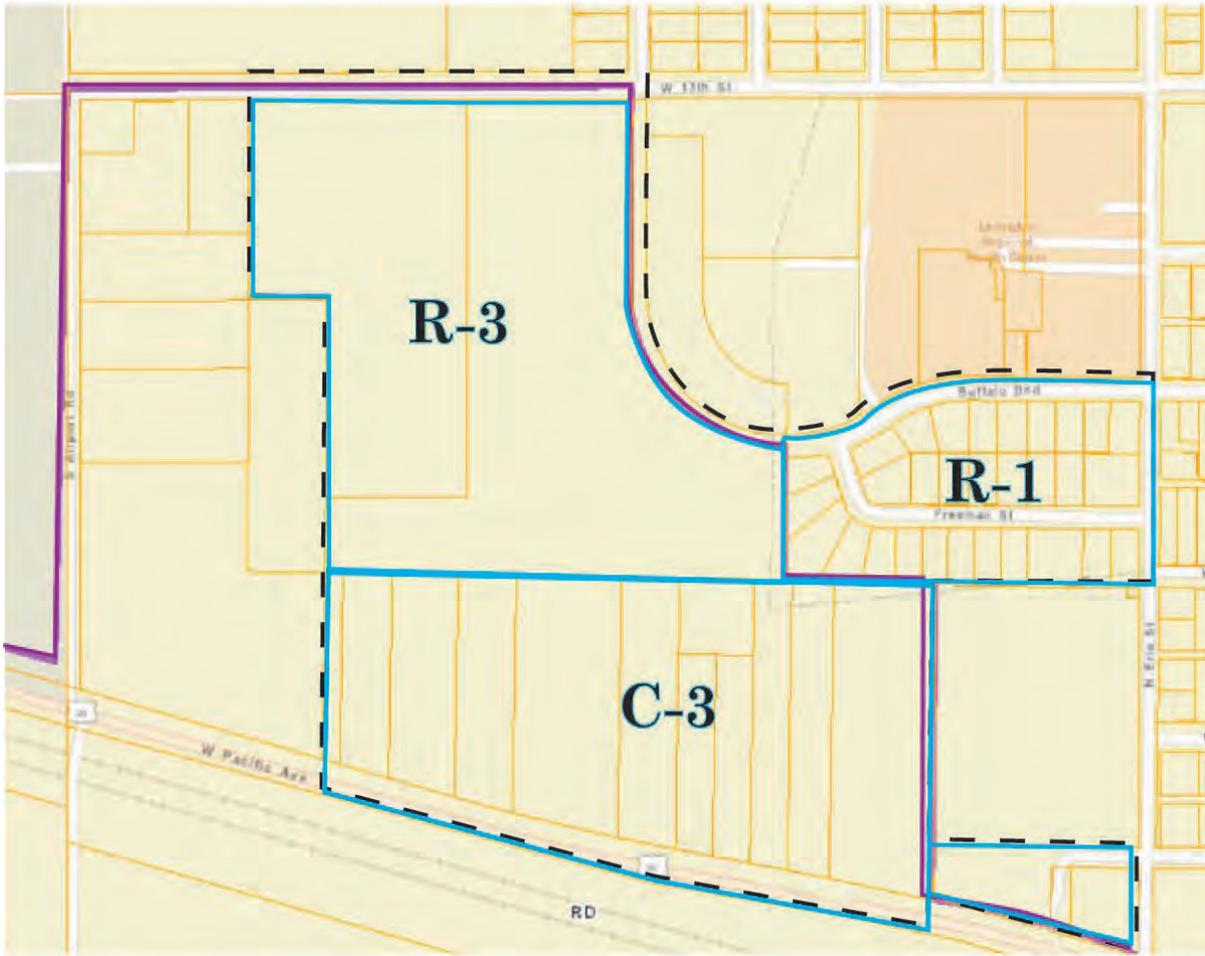
**ILLUSTRATION 6:**

CITY OF LEXINGTON, NEBRASKA  
 REDEVELOPMENT AREA #6  
 FUTURE ZONING DISTRICTS MAP
