# City of Lexington, Nebraska.

Redevelopment Area #6.

Blight & Substandard Determination Study

May, 2022.

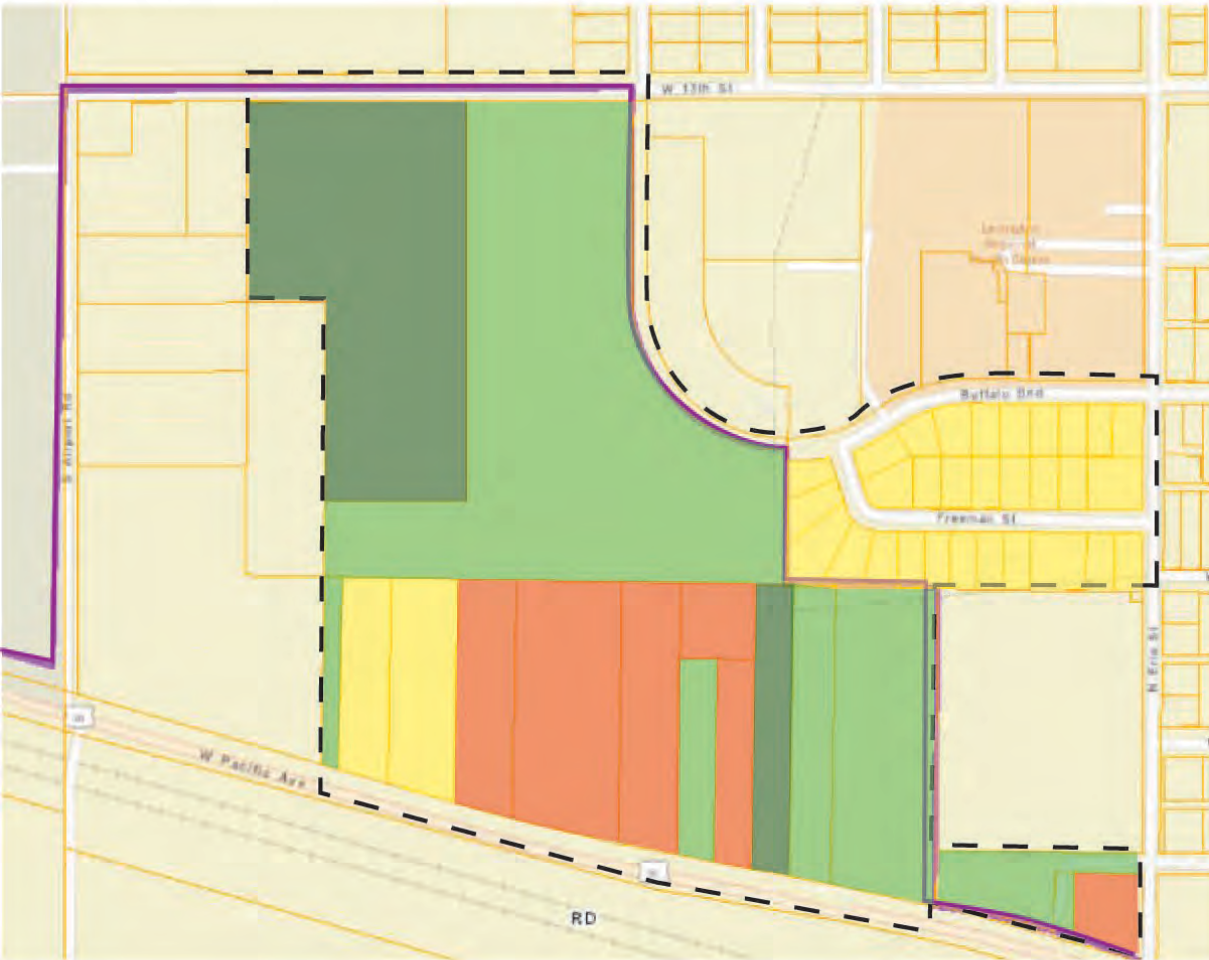
**ILLUSTRATION 2:**

CITY OF LEXINGTON, NEBRASKA  
 REDEVELOPMENT AREA #6  
 EXISTING LAND USE MAP

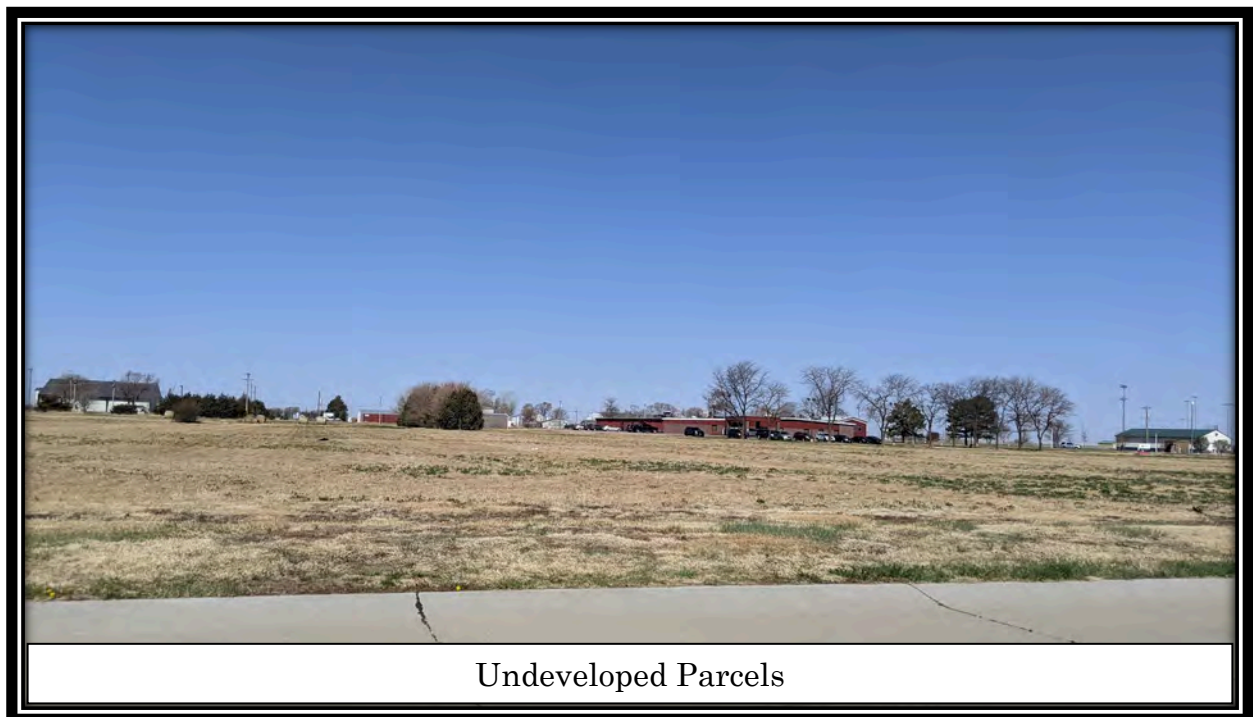
CITY OF LEXINGTON, NEBRASKA  
 REDEVELOPMENT AREA #6  
 FUTURE LAND USE MAP

**Illustration 5, Page 49**, features a **Future Land Use Map**, which identifies the land use density and coverage, as well as a general site plan for the **Redevelopment Area**. The recommendations in this **General Redevelopment Plan** are consistent with the *Lexington Comprehensive Plan* and *Lexington Zoning/Subdivision Regulations*.

The future land use patterns within the **Redevelopment Area** support commercial development on both vacant lands and existing properties adjacent Highway 30, as well as multi-family residential and public land use development on vacant lands adjacent W 13<sup>th</sup> Street.
